Urgent monitoring and analysis on Yushu Earthquake using remote sensing

Abstract: At 7:49 am on April 14, 2010, an earthquake (Ms 7.1) originated (33.2°N, 96.6°E) near Jiegu Town, Yushu Tibetan Autonomous Prefecture, Qinghai Province, China. After the earthquake, we analyzed the geological structure of the disaster region based on the “Beijing-1” images. Using the aerial images after earthquake with high resolution (0.4m) and SPOT ortho-images, we monitored urgently the disaster situation, including the damage degree of the buildings, the damage degree of the lifelines, the field disasters and the secondary disasters. The result could provide the important basis for emergency management and rescue mission.

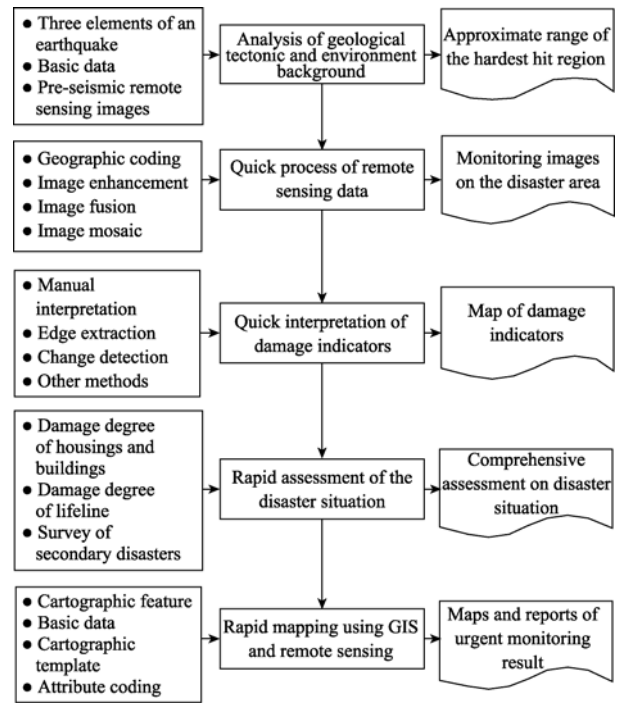
In the earthquake urgent monitoring using remote sensing, manual interpretation, change detection and other methods are used to analyze and extract the damage indicators from the remote sensing data with different resolutions and different spectral information in order to assess the disaster situation. The main technical processes include: analysis of geological tectonic and environment background, quick process of remote sensing data, quick interpretation of damage indicators, rapid assessment of the disaster situation and rapid mapping using GIS and remote sensing (Fig. 1).

Fig. 1 Urgent monitoring flow for Yushu Earthquake based remote sensing

mosaic. Then, combining with prior knowledge and remote sensing images before earthquake, the damage indicators would be interpreted rapidly by manual interpretation, edge extraction, change detection and other methods. The disaster situation could be investigated and assessed quickly, including the damage degree of housings and buildings, the damage degree of lifeline and the survey of secondary disasters. Supported by GIS technology, disaster monitoring results could be mapped, and the assessment reports be written, which would provide qualitative / quantitative and intuitive decision basis for the earthquake emergency rescue.

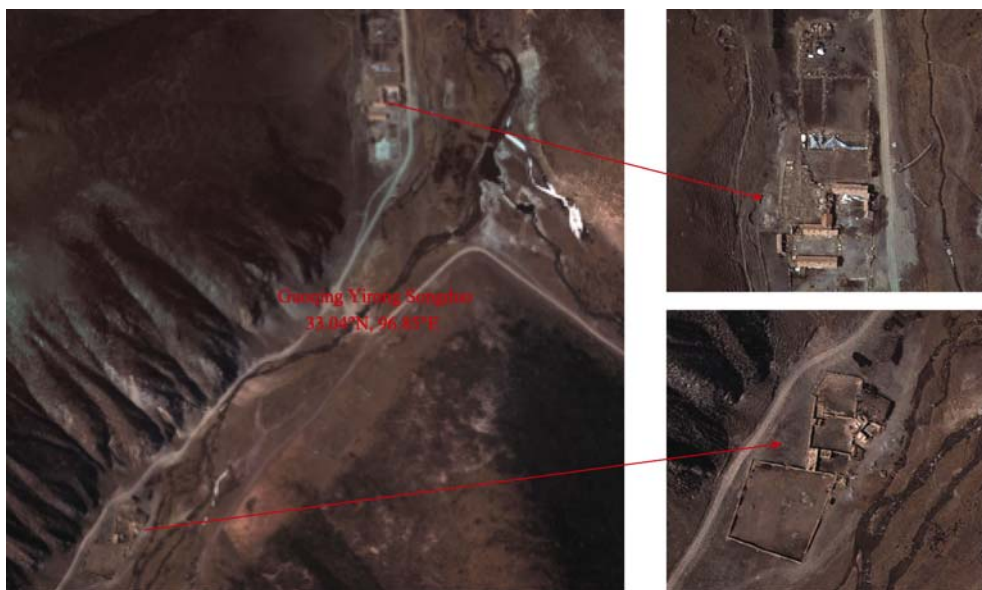
Fig. 3 Scattered buildings at the westnorth of Jiegu Town

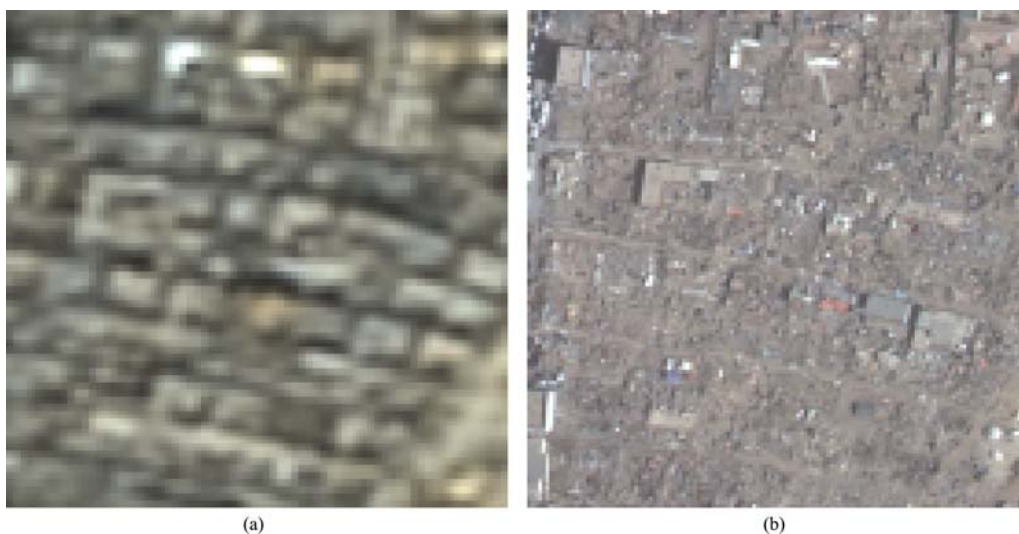
Fig. 4 Remote sensing images of the civil structure housing before (a) and after (b) the earthquake

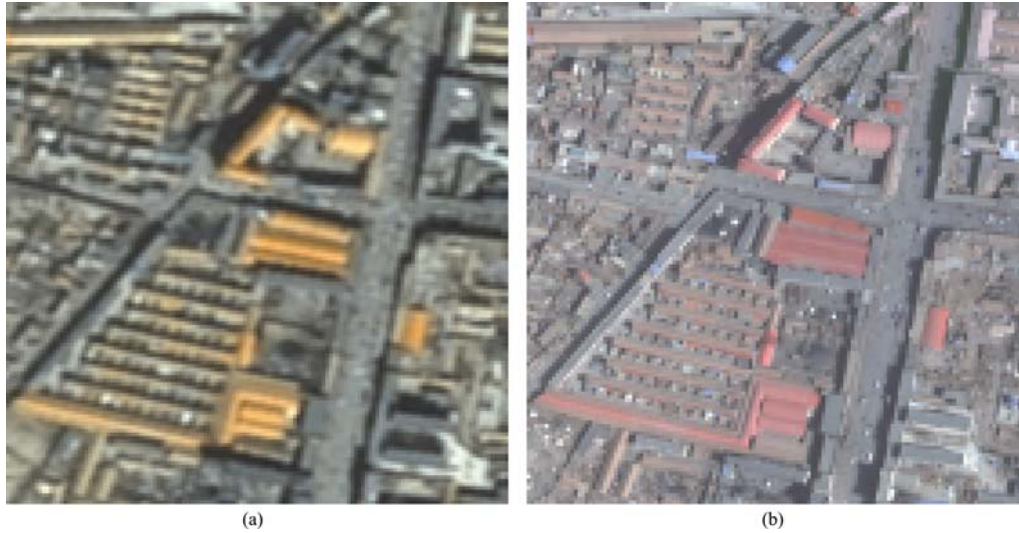
Fig. 5 Remote sensing images of the brick building before (a) and after (b) the earthquake

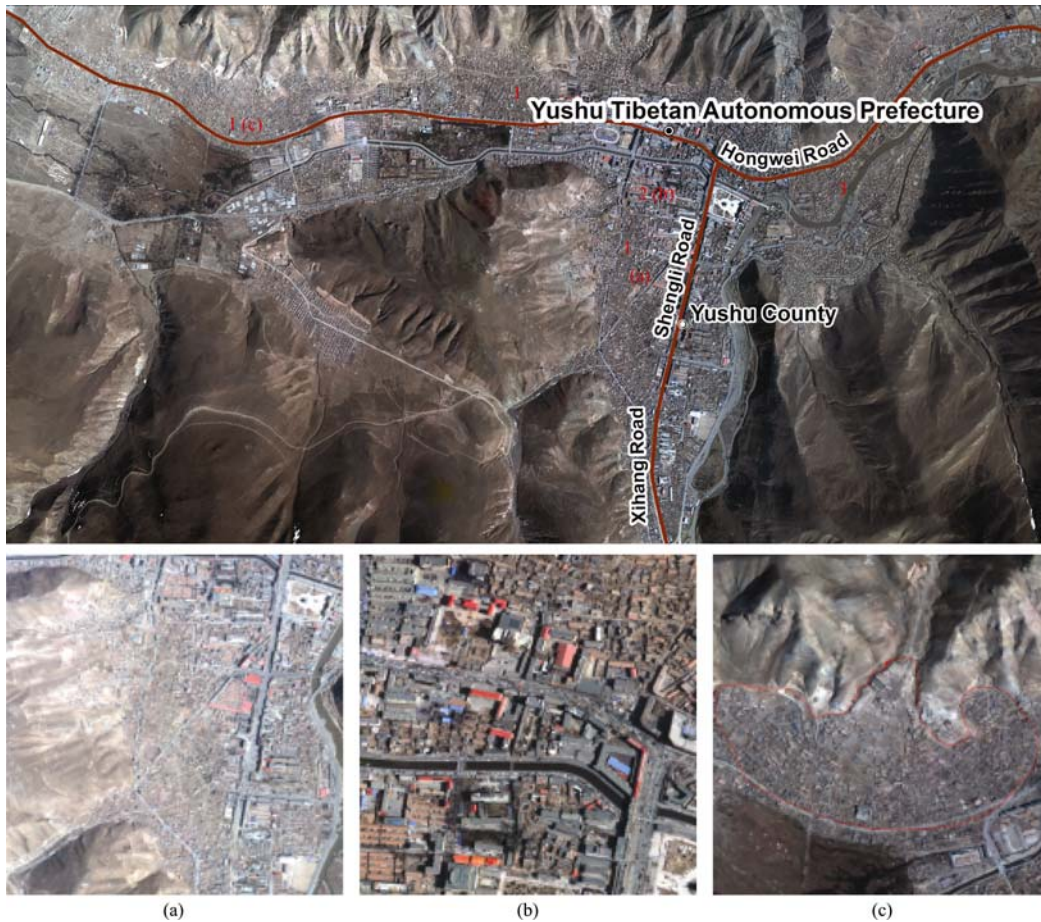
According to the interpretation result based on remote sensing images, the overall collapse rate of the housings, buildings and infrastructure in Jiegu Town was about 60%. The distribution of housing collapsed was shown in Fig. 6. Taking Victory

Road as the boundary, lower rate of housing collapsed in the eastern region for locating far away to the Ganzi—Yushu active fault zone, except for the old civil structure housings. In the western region of Victory Road, especially in the southern section (Fig. 6 (a)), the damage was so serious that almost all of the

Fig. 6 Map of collapsed housing in Jiegu Town, Yushu County

(a) Region of the south of Jiegu Town; (b) Building of frame construction along the Provincial and county roads; (c) Collapse of housing on the alluvial fan
 1 Civil structure housing almost fell destroyed completely; 2 Few brick buildings collapsed; 3 Few civil structure housings collapsed

civil engineering structures housing fell destroyed completely. Some of the brick building was also collapsed, Many of the uncollapsed ones suffered serious damage to the structure, which are difficult to repair. For frame structure, the office buildings for government and the services buildings along the provincial and national highway were almost in good condition (Fig. 6(b)).

From after-seismic aerial images, the interpretation result showed that the collapse rate of the housings on an alluvial fan in the west side of Jiegu Town (Fig. 6 (c)) reached up to 86%. There might be two reasons: (1) In that alluvial fan after years of weathering, the surface was relatively flat and solid, but the lower soil had been eroded, so that the structure was not stable enough. (2) The region was near the fault zone. Therefore, for the post-disaster reconstruction and the future residential land, we should keep away from the alluvial fan.

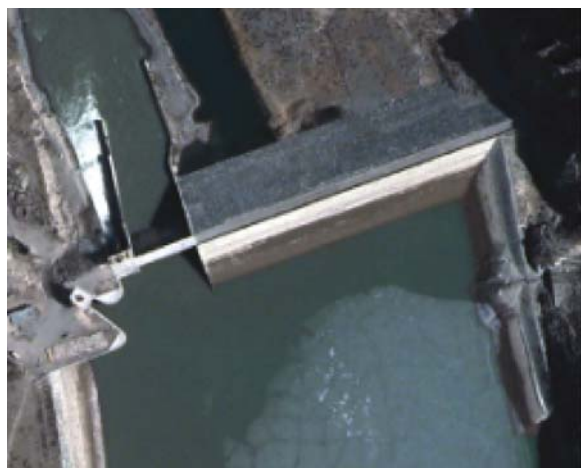
The reservoir dam located in the south, 10.5 km from Jiegu Town Yushu County, was largely intact (Fig. 9).

Fig. 9 Aerial image for The reservoir dam located in the south, 10.5 km from Jiegu Town

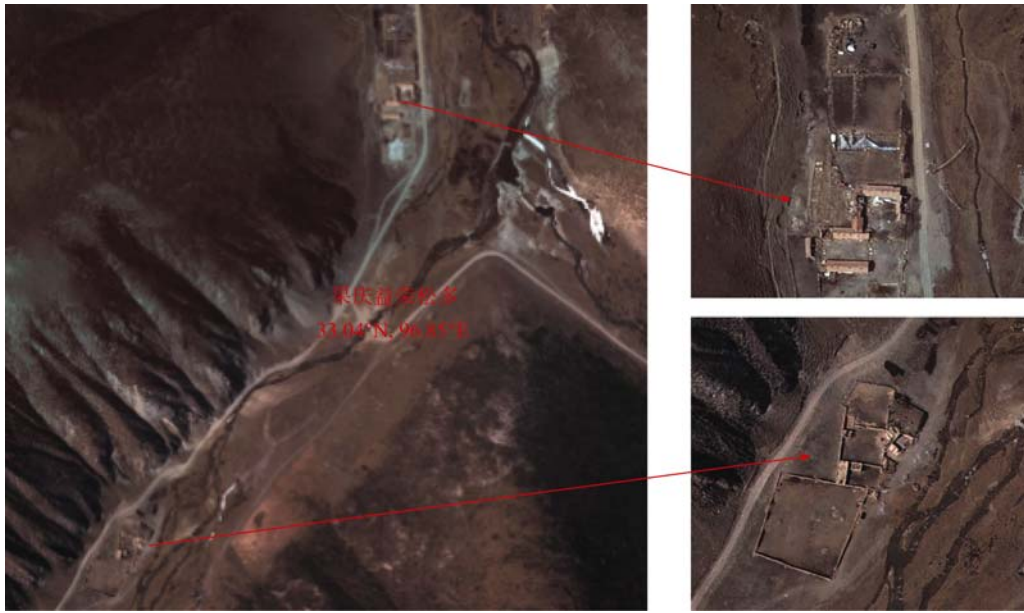
生区域人口分布相对集中, 在玉树县政府所在地结古镇外, 房屋建筑多零散分布于山谷地区(图 3), 因此房屋建筑物的主要损毁应集中于玉树县结古镇。而穿越结古镇的省道(S308)和国道(G214)及结古镇南 10.5km 通天河支流上的水库大坝则应作为生命线工程重点调查。

图 3 在结古镇周边(西北 14km)零散分布的房屋

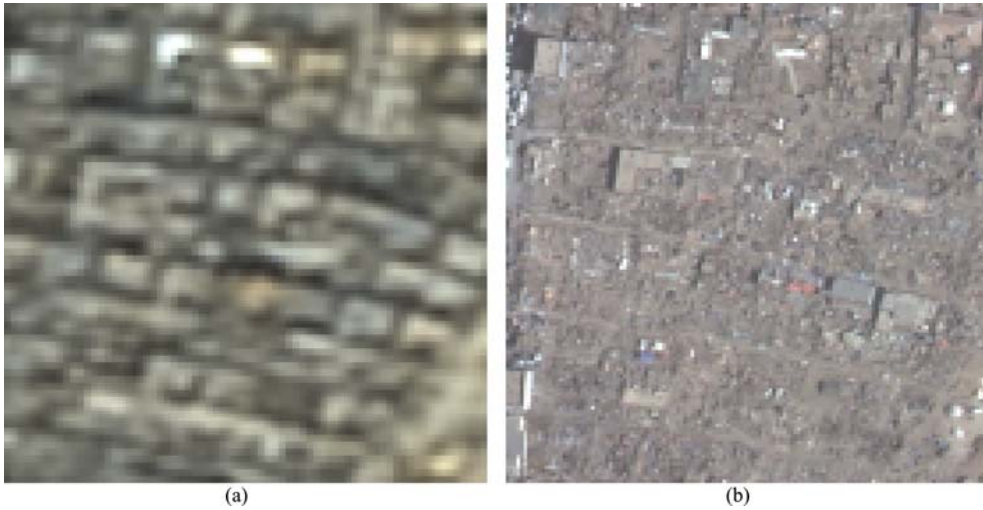
由于此次地震有前震、主震和余震, 通过玉树—甘孜活动断裂带活动性分析, 初步判断地震将给低层土木结构的房屋建筑造成巨大损坏。根据地震前后高分辨率的遥感影像对比分析: 震区内的低矮老旧土木结构建筑基本倒平全毁(图 4), 从震后影像上无法分析其纹理信息, 必须以震前高分辨率影像作为辅助数据进行判识; 砖混结构房屋建筑只有少部分倒塌, 多为结构受损, 在影像上可判识出其纹理信息(图 5)。

图 4 土木结构建筑震前(a)和震后(b)遥感影像

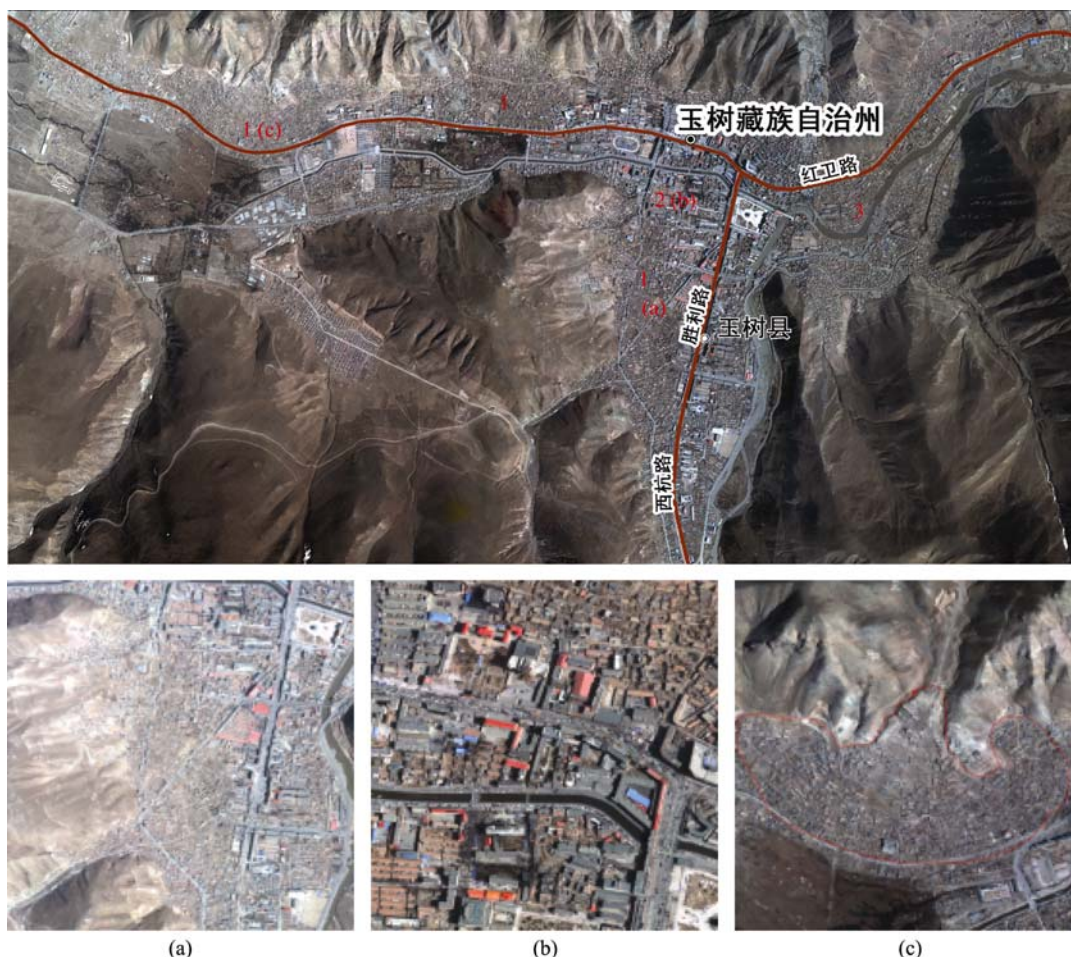
根据判识监测结果分析,玉树县结古镇房屋建筑及其附属基础设施总体倒塌率为 60%左右,房屋倒塌的总体分布情况为(图 6):以胜利路为界东部地区多为砖混结构房屋,离玉树—甘孜活动断裂带较远,房屋倒塌率较低,除了老旧土木结构房屋倒塌外,砖混结构房屋只有零星倒塌;胜利路以西、胜利路南段地区房屋倒塌严重(图 6(a)),土木结构房屋建筑大多倒平全毁,砖混结构房屋建筑有少部分倒塌,即使未倒塌的也多为结构严重破坏,难以修复。玉树县行政机关和沿国道省道的服务业楼房以框架结构为主,基本完好(图 6(b))。

在结古镇西侧(图 6(c)),一处冲积扇区域发生大量房屋倒塌,根据航空遥感影像解译结果,其房屋倒塌率达 86%。这是由于冲积扇地区土质松软,结构不够稳定,且该地区位于地震断裂带附近,因

图 6 玉树结古镇房屋倒塌分布示意图

(a) 结古镇南部受灾严重地区; (b) 沿国道省道的服务业楼房以框架结构建筑; (c) 冲积扇上的倒塌房屋
1 为土木结构房屋倒平全毁; 2 为砖混结构房屋少部分倒塌; 3 为土木结构房屋少部分倒塌

此在地震中造成灾难性后果。在灾后重建和今后批准住宅用地时应尽量避免开冲积扇区。

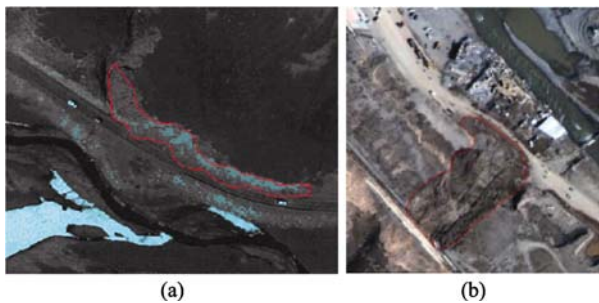
玉树地震中, 由于地质结构、震级等原因, 根据遥感监测结果分析, 并未形成大规模的场地灾害和次生灾害(图 8), 对国道省道及水利设施造成严重损毁, 也未堵塞河道形成大范围堰塞湖。

通过航空遥感影像监测分析, 在航空遥感影像监测范围内, 省道(S308)和国道(G214)等主干道路未受地震场地灾害严重影响, 未出现道路严重损毁情况, 部分路段受滑坡和震陷轻微影响, 如图 8(a)山体滑坡掩盖部分省道路面, 图 8(b)震陷导致国道部分路面塌陷。

图8 玉树地震场地灾害
(a) 滑坡; (b) 震陷

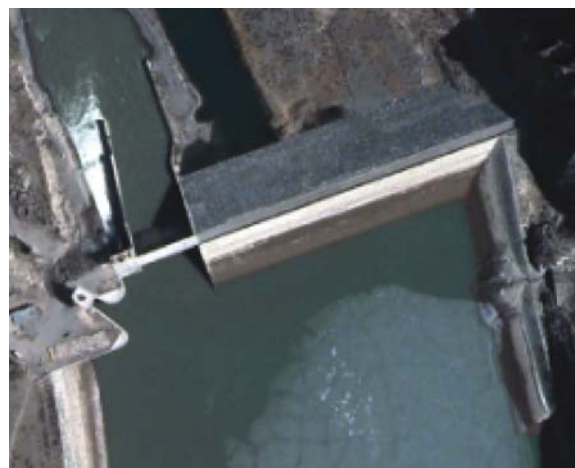
位于玉树县结古镇南 10.5km、通天河支流上的水库大坝基本完好(图 9)。

图9 水库大坝航空影像
